## Deliverable D4.3

# Candidate materials for couplings and casings

Grant agreement no.	654497		
Duration	01.02.2016 – 31.01.2019		
Work package	WP4 – Flexible coupling and casing materials		
Type	R - document, report		
Dissemination level	PU - public		
Due date	31.07.2016		
Actual submission data	12.07.2016		
Lead author	I.Thorbjornsson		
Contributors			
Version	1.0		
Document status			
Change history	Version	Date	Changes

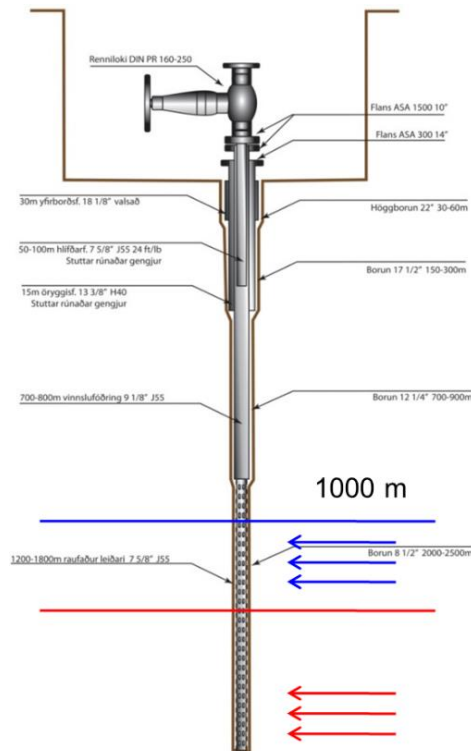
**Figure 2.1.** Schematic layout of well KJ 39.

Corrosion in geothermal wells has been in research focus for many years. The importance of understanding why corrosion occurs and the chemical reaction of the material surface with geothermal fluid is of high importance for long life of geothermal wells. The pH level together with geothermal gases and free halogens like Cl<sup>-</sup> are known corrosion factors. The effect of mixing zones within the well where f.ex. colder steam entering the well mixes with higher temperature steam from lower part of the well is also important as it can create local conditions which are not possible to monitor at the surface. This situation, illustrated in Figure 2.1, can result in very aggressive environment and cause rapid corrosion as can be seen in Figure 2.2. In this case, the steel used in the affected well showed high corrosion rate where the 12 mm wall thickness of the slotted liner was fully corroded with severe pitting corrosion and hydrogen embrittlement. The liner was retrieved from the well in this condition after only few weeks of service.

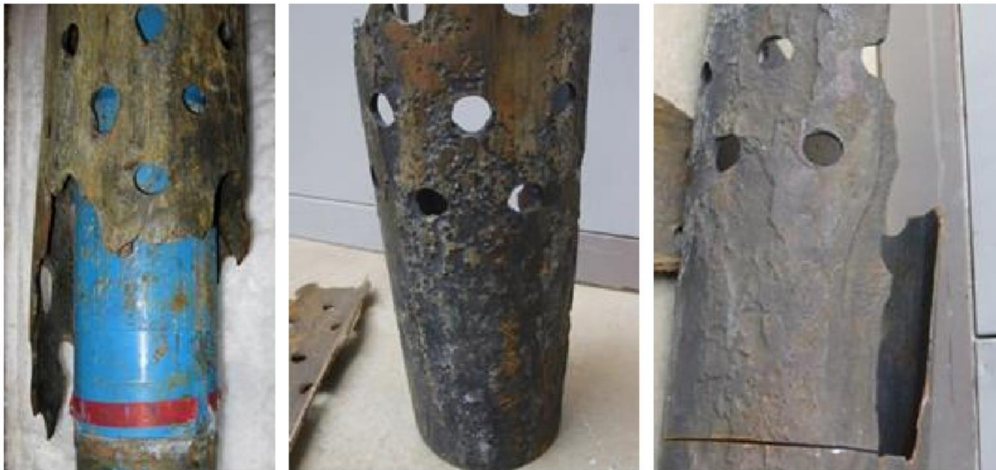
**Figure 2.2.** Pictures showing severe corrosion of well liner in the Krafla geothermal field well KJ-39. Corrosion of well liner at a blending point between HCl containing dry steam from lower geothermal system and wet fluid from upper system.

In Figure 2.4.3 two specimens from tensile testing of material from the KJ – 39 well in Krafla are shown. It can clearly be seen that the specimen taken from liner section 53 has a brittle fracture but the one from first section of the liner is with ductile fracture. This is due to Hydrogen Embrittlement as discussed earlier and revealed in Figure 2.2.

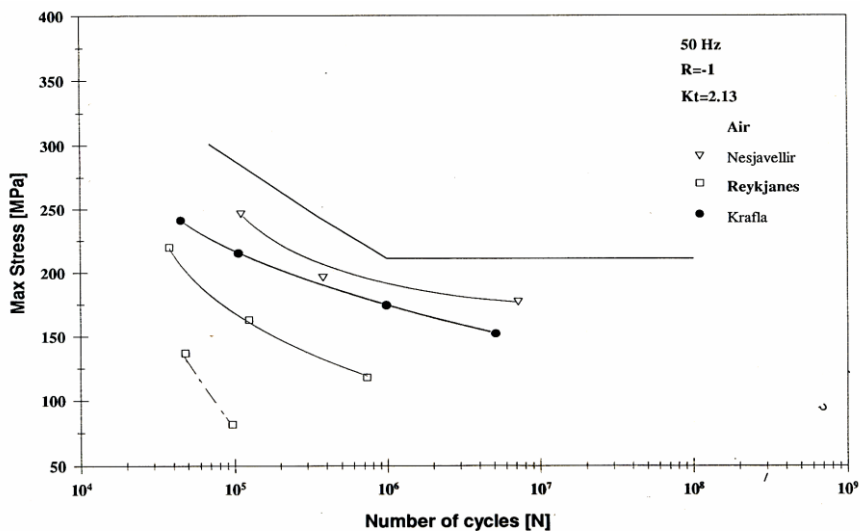
**Figure 2.3.** S-N curves for 12% Cr turbine steel in three geothermal sites and in air. The effect of hydrogen is evident in the Reykjanes results. (Thorbjornsson, 1995).

It has been shown that during fatigue testing in geothermal steam, this variation in gas content as well as the presence of Cl<sup>-</sup> in the Reykjanes area result in different material performance in these three fields. Figure 2.3 shows corrosion fatigue testing of turbine material of the 12% Cr type in air as well as geothermal in situ testing.

Further it can be seen in Figure 2.3. that there are actually two curves for testing in the Reykjanes area. This is believed to be due to variation in steam velocity during testing, where the curve with higher live time is where low flow rate was set to normal operation, and the other when the flow rate was higher. With increased flow rate the risk of droplets carrying Cl<sup>-</sup> ions entering the test chamber is higher. It should be noted that each data point on the graph is a mean value of at least 4 specimen tested.

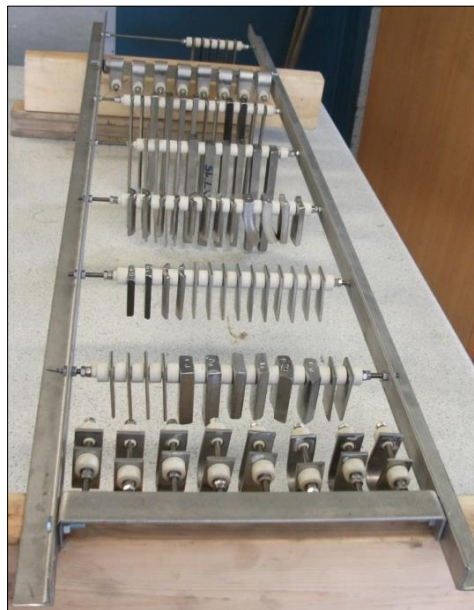
**Figure 2.1.1.** *Picture taken of the material test rack for testing in the IDDP-1 well in the Krafla area in NE Iceland. Specimens were both stressed (u bend specimens) and unstressed, welded and not welded (Karlsdottir et al., 2015)*

Figure 2.1.2 shows how the test rack from Figure 2.1.1 is covered with scaling when inspected after some three weeks of testing. The silica scaling is totally sealing off the specimen from the steam and by that preventing corrosive elements to come into contact with the test coupons, lowering or even stopping corrosion of the materials.

Results from testing down-hole in well IDDP-1 are shown in Figure 2.2.4. Coupons were attached to a test rank as shown in Figure 2.1.1 and put inside pipe from the well to silencer as seen in Figure 2.1.2. As can be seen, the corrosion rate for low-medium carbon steels are much higher than for stainless steel types as expected and the higher alloyed Ni alloys are with very low values close to detection limits. Lower alloyed Ni alloy N088255 suffer from higher corrosion rate.

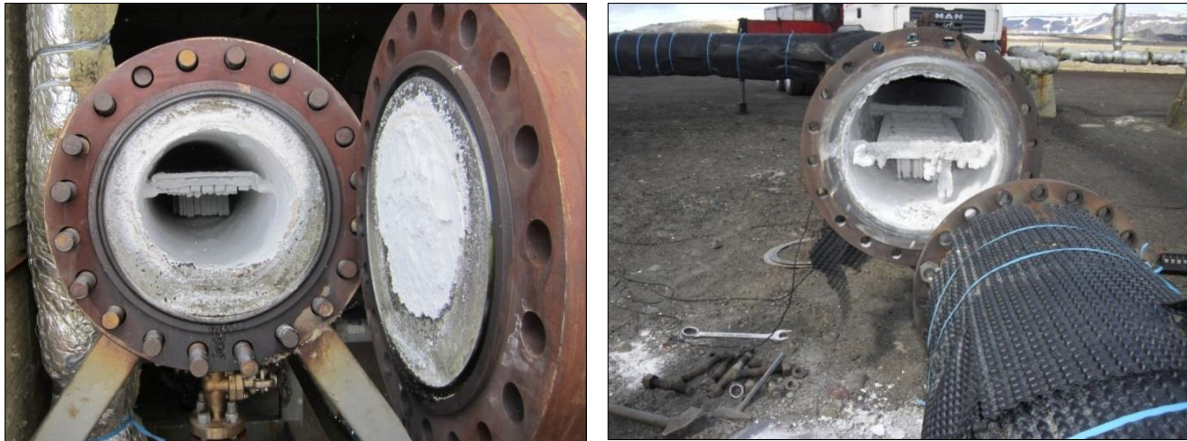
**Figure 2.1.2.** Pictures taken of the material test rank inside the pipe leading to the silencer of the IDDP-1 well. Situation after three weeks of testing revealing massive scaling inside the pipe and on the test specimens. (Karlsdottir et al., 2015).

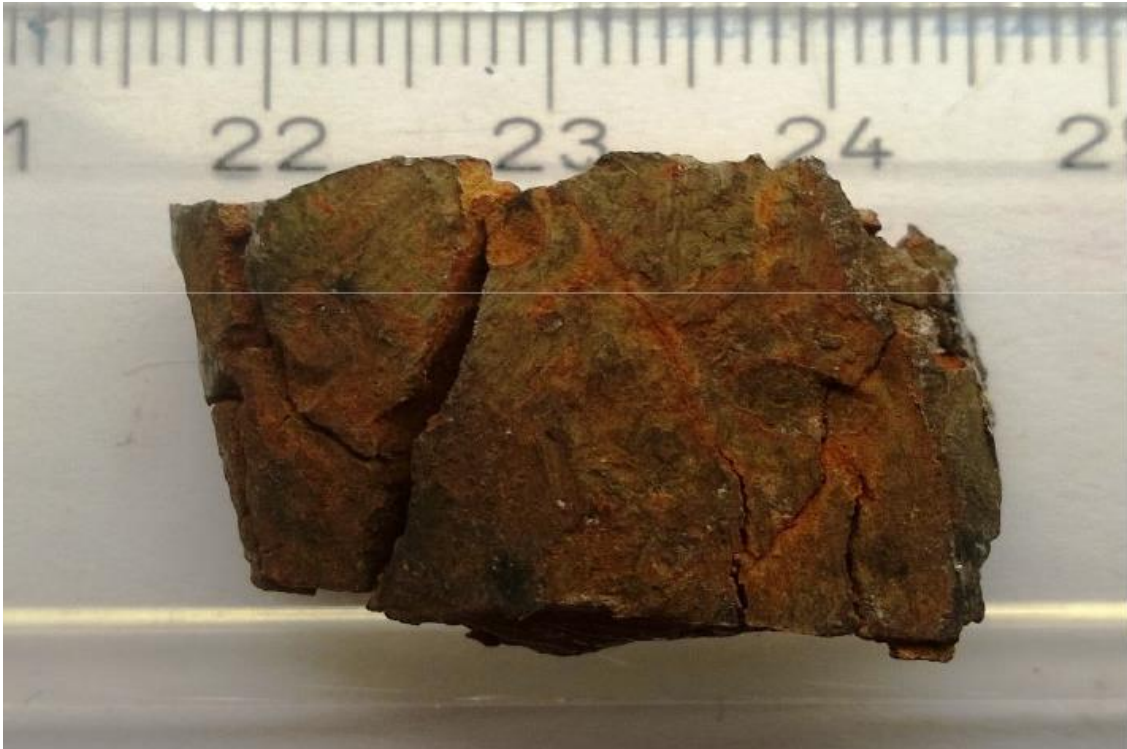
**Figure 2.2.1.** Material from either liner or casing in the IDDP-1 well. Retrieved during flow testing of the well (Photo from A. Einarsson).

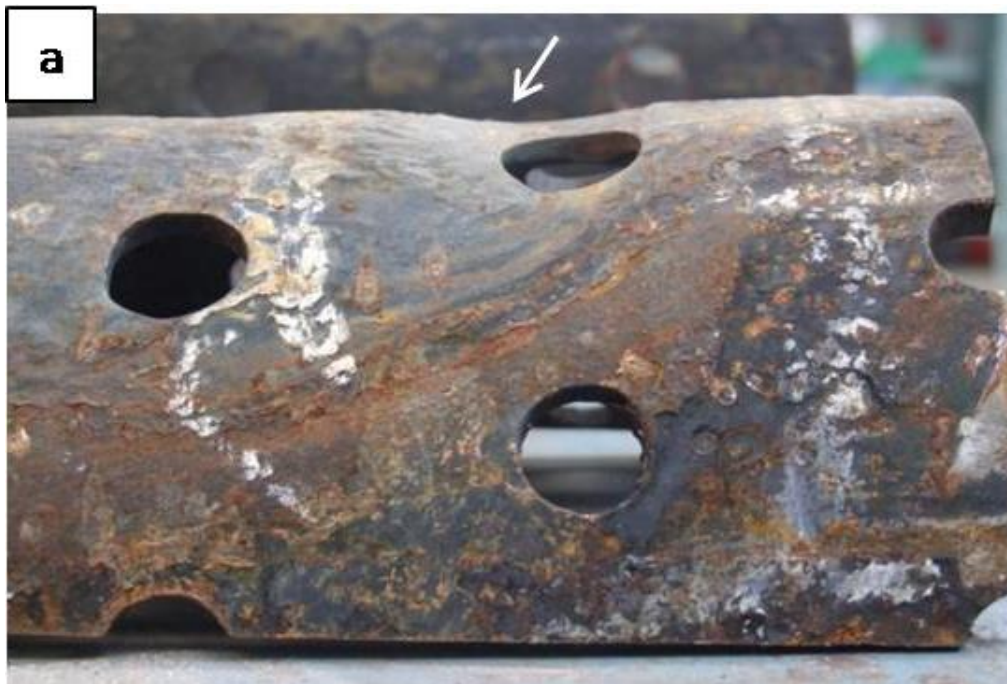
**Figure 2.2.2.** Retrieved part of liner from the KJ 39 well in Krafla. Severe damages due to uniform corrosion. No corrosion products detected.

The anodic reaction produces metal ions  $\text{M}^{n+}$ . The metal ions generally combine with other ions in the electrolyte to form a solid corrosion product on the metal surface were the most common of these is rust which consists of iron oxides and hydroxides,  $\text{Fe}(\text{OH})_3$  -  $\text{Fe}_2\text{O}_3$  (red rust) or  $\text{Fe}_3\text{O}_4$  (magnetite, black rust). In highly acid fluids little or no solid corrosion products are generally formed on the corroding metal surface as can be seen in Figure 2.2.2.

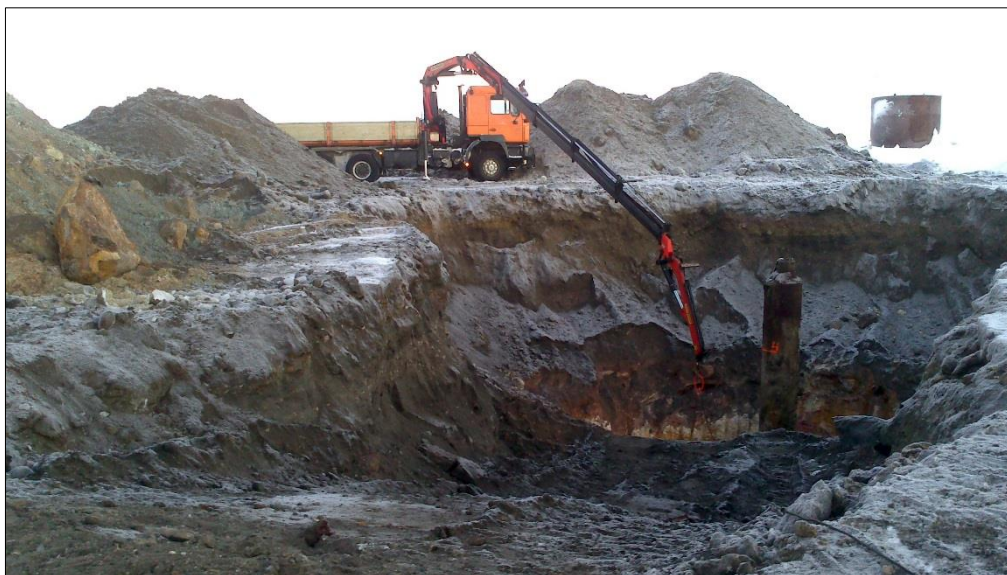
**Figure 2.2.3.** Picture showing the retrieve of the uppermost 8 meters of the IDDP-1 wellhead for inspection (Photo from the National Power Company – Landsvirkjun).

Uniform corrosion is the most common corrosion form for carbon and low alloy steels. This form of corrosion requires moisture or other electric conducting media on the surface where anode-cathode reaction can take place. This corrosion is measured on coupons where they are weighted before and after testing. The weight loss is related to the surface area of the coupons and often represented as corrosion rate in mm/year. General acceptance for corrosion rate in geothermal environment is not set by standards but often the acceptance limit is set to 0.1 mm/year. This form of corrosion is more often discovered on the outside of wells, especially at the wellhead where the casings exceed from the cement. This is mostly due to the fact that it is not possible to measure or detect degradation due to corrosion in well material down-hole. Therefore, the cases for detecting corrosion and measure its effect have been on material pieces that have been detected coming up with the steam as seen in Figure 2.2.1, or where the liner has been retrieved to surface after exposure in the well, see Figure 2.2.2. In some cases, the uppermost 8-10 meters have been excavated after the well was shut down permanently by removing the ground surrounding the well as can be seen in Figure 2.2.3.

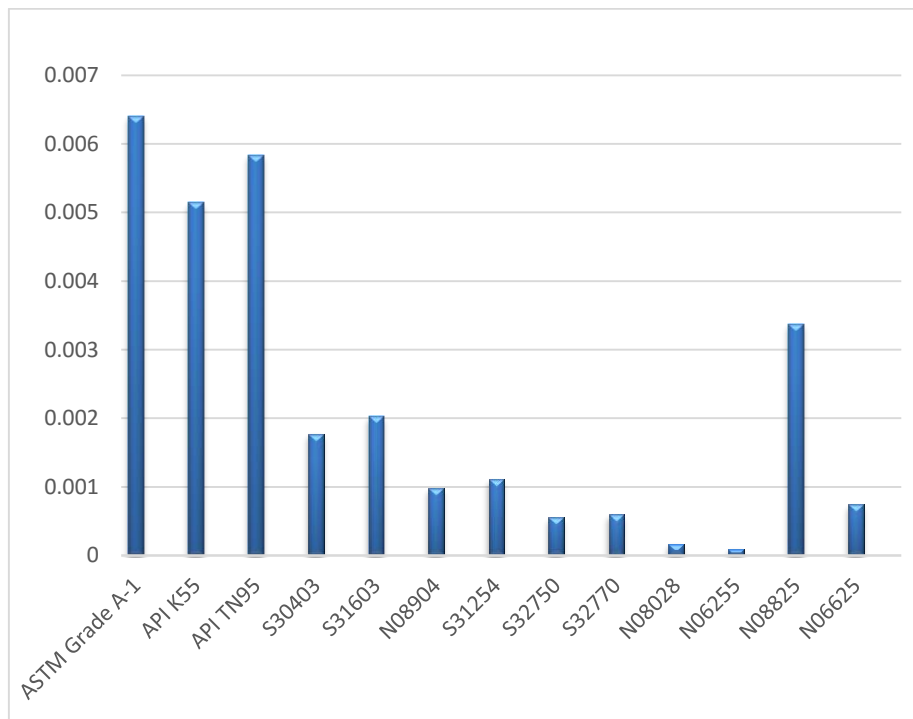
**Figure 2.2.4.** Measured corrosion rates in mm/year of the materials tested in the IDDP-1 well. (Karlsdottir et al. 2015)

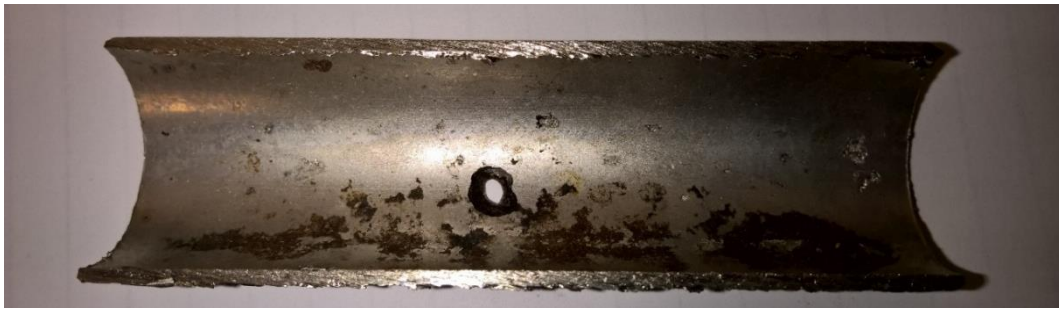
**Figure 2.3.1.** *Pitting corrosion on the inside of a pipe of stainless steel type AISI 316. (Photo Thorbjornsson).*

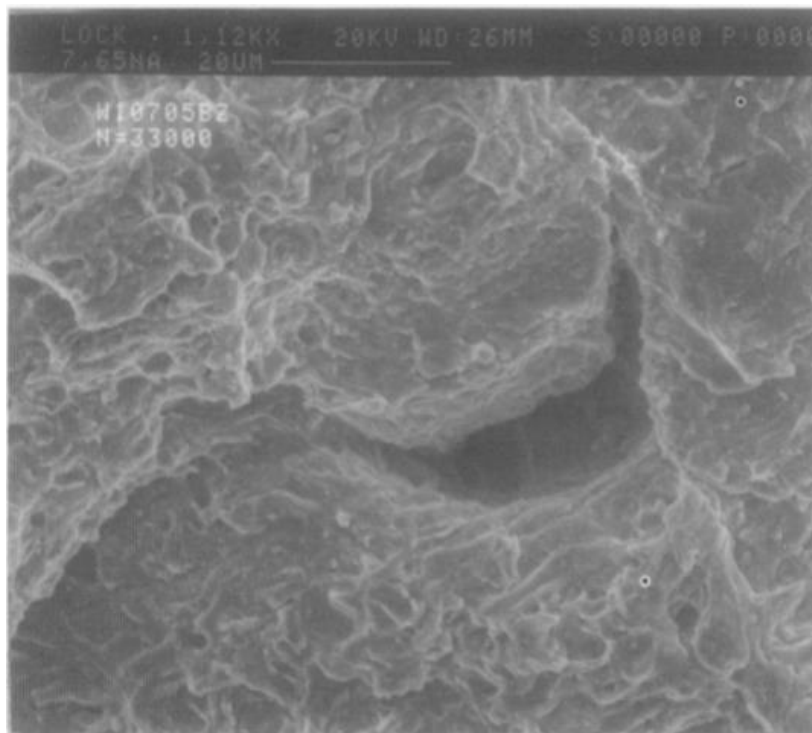
**Figure 2.4.1.** *An image from Scanning Electron Microscope (SEM) of 17-4 ph steel after corrosion fatigue testing (Thorbjornsson, 1995). Picture reveal cracking around the grain boundary due to hydrogen embrittlement.*

Geothermal gases contain Hydrogen Sulphide,  $H_2S$ , but the amount varies from field to field as can be seen in Table 2.1. The gas can react with the metal surface were either  $MnS$  or  $FeS$  form and the metal sulphide prevents formation of hydrogen molecules on the surface resulting in Hydrogen ions diffusing into the steel as well as some ions escaping into molecules in the geothermal steam. The ions diffusing into the steel will either pass through the metal or stop typically at micro voids, slag inclusions or other defects. In these voids the hydrogen ions form molecules and by that multiply in volume. This will increase the pressure in the micro voids and the pressure can be so high as to form crack inside the metal. This phenomenon can clearly be seen in Figure 2.4.1 (Thorbjornsson, 1995).

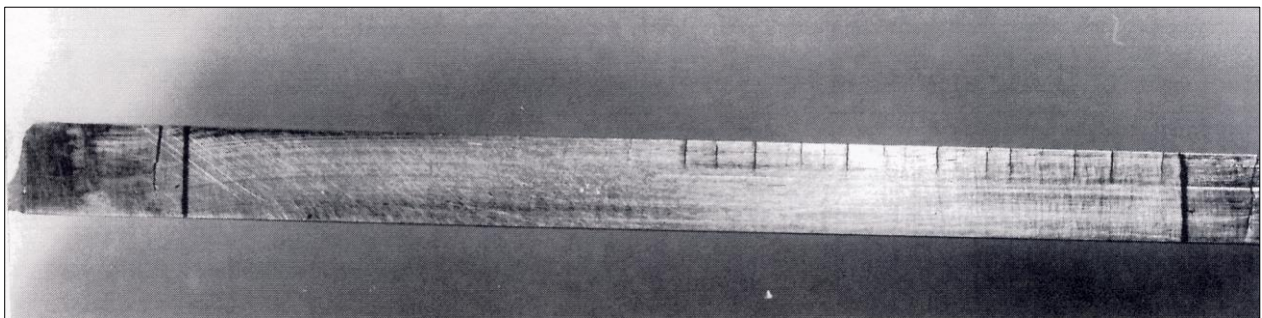
**Figure 2.4.2.** A tensile testing specimen after slow stain testing. Material taken from Well NJ 5 in the Nesjavellir geothermal area in Iceland. Several cracks formed during testing revealing hydrogen embrittlement. (Thorbjornsson, 1994).

Slow strain testing ( $2 \times 10^{-6}$ ) of material from existing wells in Iceland (Well 8 in Reykjanes and Well 5 in Nesjavellir) (Thorbjornsson 1994) revealed that although the material has no sign on surface the ductility of the steel is reduced significantly and the material is in brittle stage. Figure 2.4.2 shows a picture of one of the tested tensile specimen revealing severe cracking during testing due to hydrogen uptake and cracking. In these cases, the material is unable to react to higher tensile stress such as due to cooling and warming up again. The experience from operating wells in these fields have not showed any incidents like cracking of the well casing materials so the stresses are probably lower than the brittle material can tolerate. This is though a concern if the need for rapid cooling occurs.

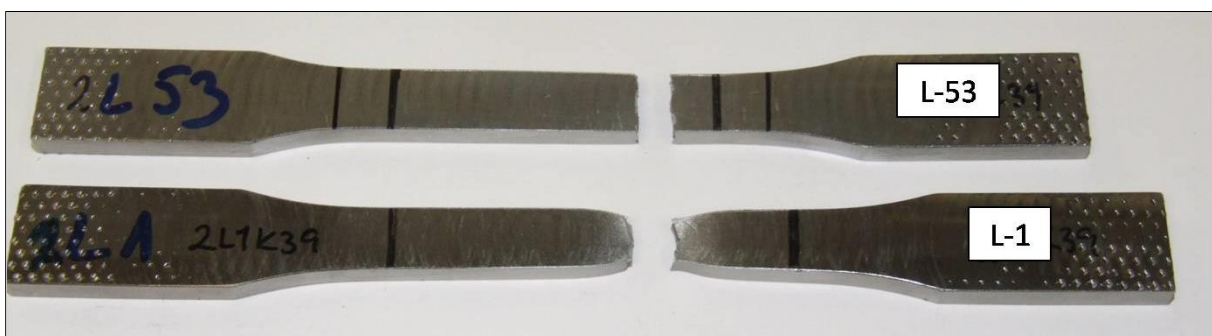
**Figure 2.4.3.** A tensile testing specimens after slow stain testing. Material taken from liner, L-1 is from the first section of the liner and L-53 from the 53rd section of the liner. L-1 is with ductile fracture but the specimen from L-53 with brittle fracture. (Karlsdottir and Thorbjornsson, 2013).

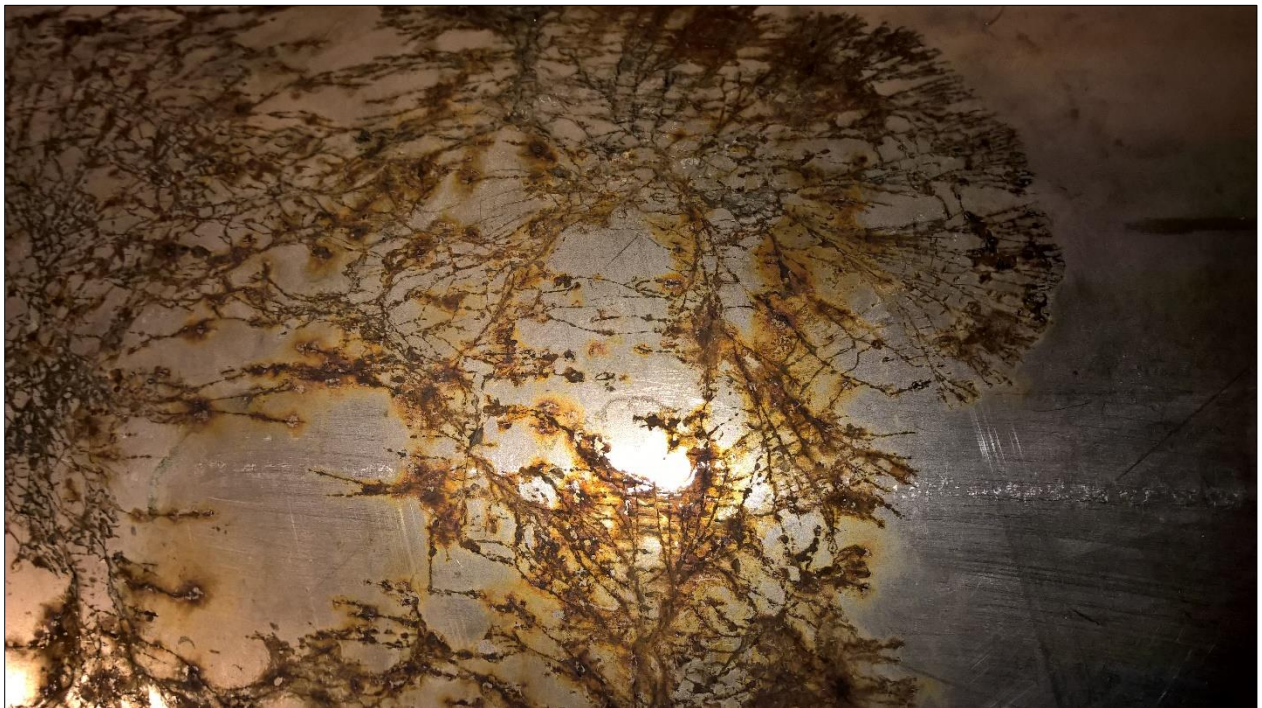
**Figure 2.5.1.** *Stress corrosion cracking on the outside of a pipe from AISI 316 stainless steel (Photo Thorbjornsson).*

Stress corrosion cracking (SCC) is a phenomena were stress, material composition and environmental effects play a vital role. SCC is often connected to, but not only, use of stainless steels of the austenitic type. When tested in geothermal the use of pre stressed specimen is used. In following the discussion will be on so called U-bend specimens with two strain levels, 12.5 and 20% and the testing was done in the IDDP-1 well in Krafla geothermal area (Karlsdottir et al., 2015). No cracking was found in the S235 carbon steel as expected. SCC cracks are observed in the S30403 and S31603 austenitic stainless steels at both strain levels, and for the S31803 duplex stainless steel at the higher strain level. The cracks that are identified as SCC cracks are cracks that are perpendicular to the surface and the tensile stress as is conventional for SCC cracks. Different kinds of damages, crack-like, were found in cross-sections of the N08904, S312542, and S32750 U-bend specimens at the higher strain level and for the S31803 specimen at the lower strain level. These cracks are parallel to the metal surface, as can be seen in Figure 2.5.2, 2.5.3 and 2.5.4, and thus cannot be attributed directly to SCC; indicating at least a different cracking mechanism to that of the conventional stainless steel. The S30403, S31603 and S31803 all have lower molybdenum (Mo) content between 0-3.5% while the other stainless steels have higher than 4% Mo. Mo is known to increase the resistance to pitting and crevice corrosion in stainless steels but it is not evident here whether that influenced the SCC crack formation.

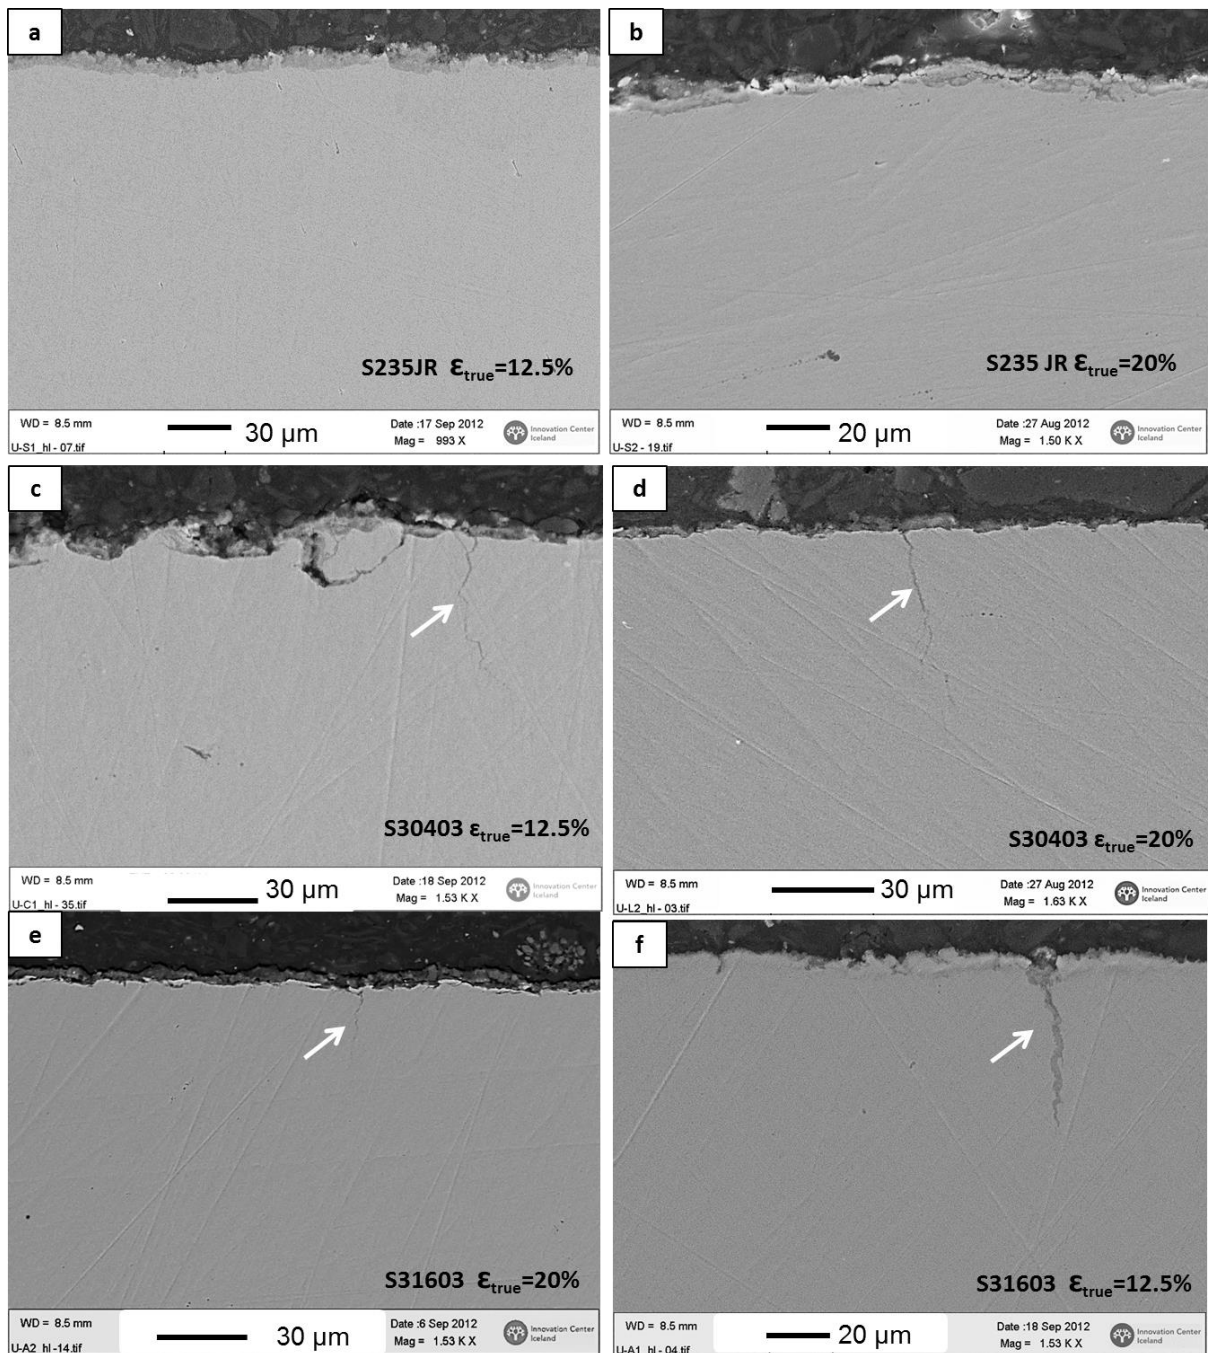
**Figure 2.5.2.** SEM images of the cross-section of the U-bend specimens; (a)-(b) the carbon steel with no SCC cracks; and (c)-(f) the S30403 and S31603 austenitic stainless steels with SCC (Karlsdottir et al., 2015).

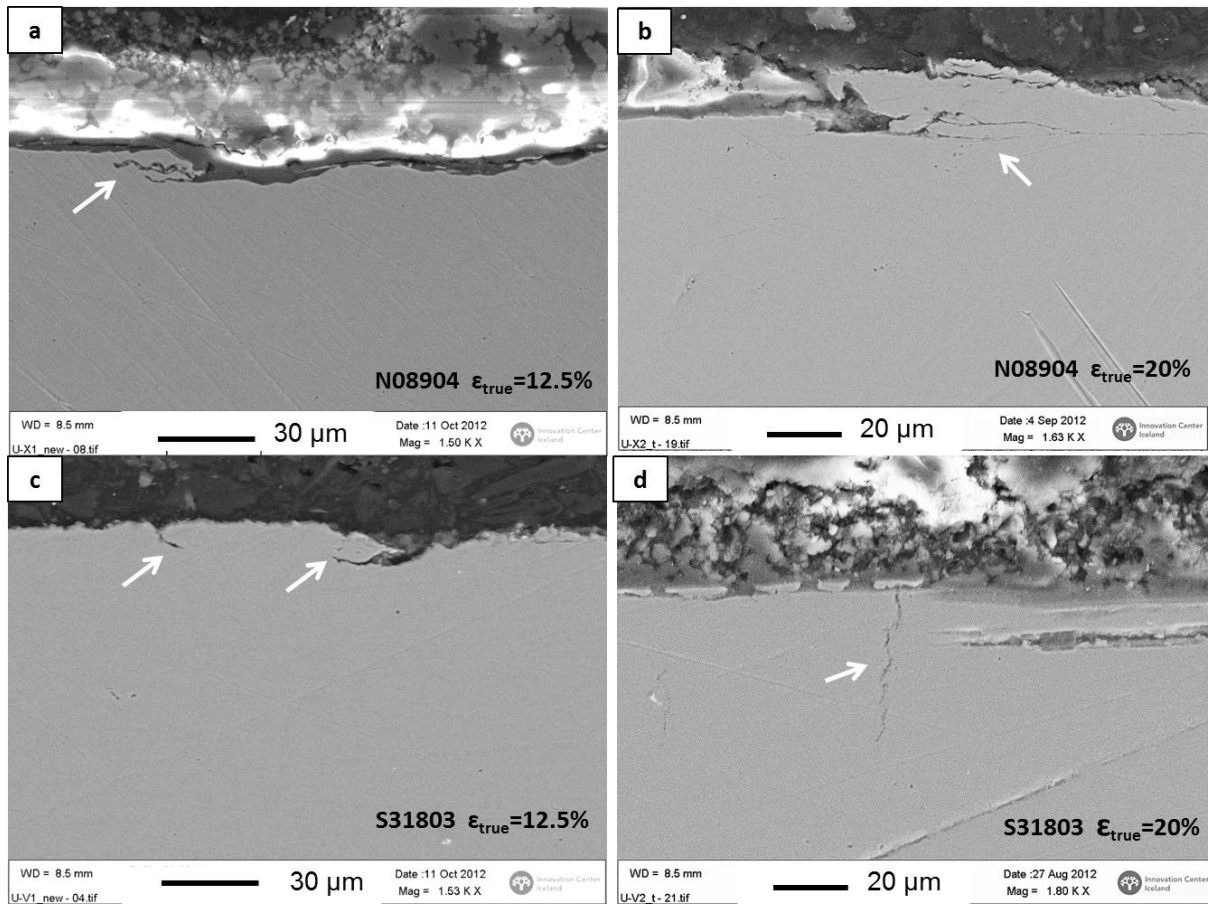
**Figure 2.5.3.** SEM images of the cross-section of the U-bend specimens; (a)-(b) the N08904 with parallel crack like damages at both strain levels; (c)-(d) the S31803 duplex stainless steels with parallel crack like damages at lower strain level and SCC cracks at the higher strain levels. (Karlsdottir et al, 2015).

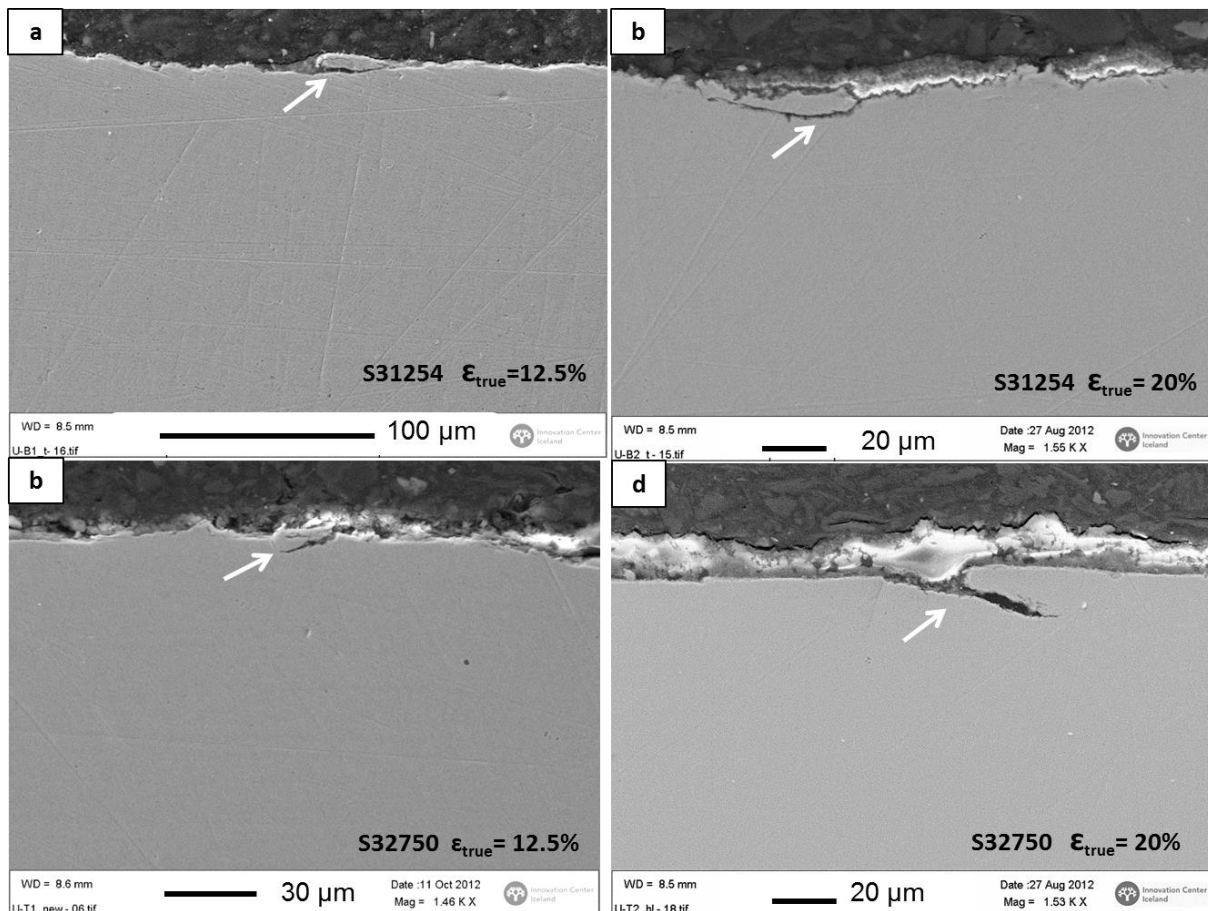
**Figure 2.5.4.** SEM images of the cross-section of the U-bend specimens; (a)-(b) the S31254 austenitic stainless steel and (c)-(d) the S32750 duplex stainless steels with parallel crack like damages at both strain levels. (Karlsdottir et al., 2015).

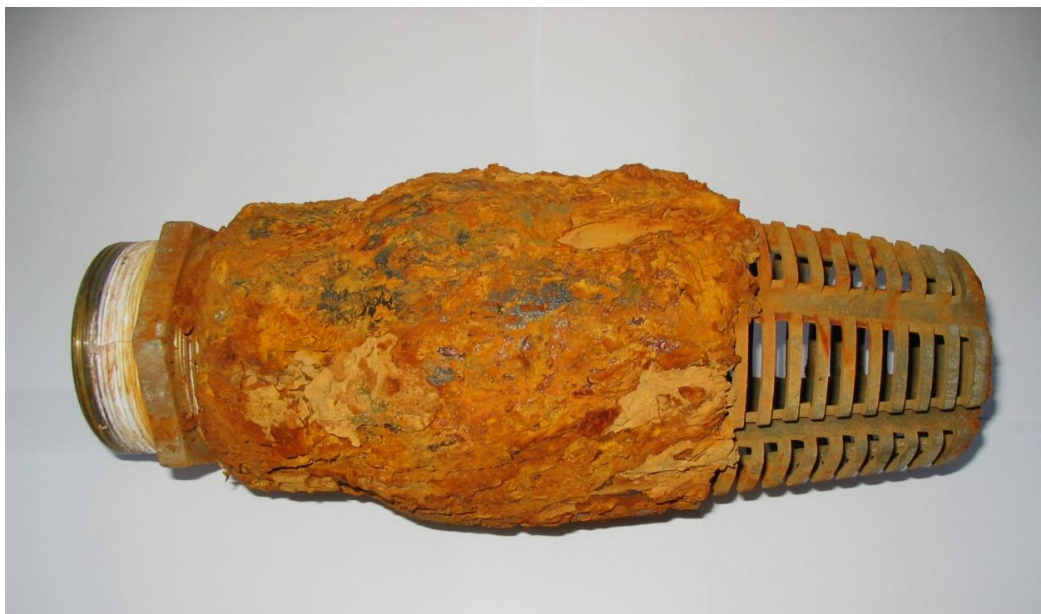
**Figure 2.6.2.** *Figure showing severe galvanic corrosion on one-way valve where the house is made of Cast Iron with connector and sieve made of Bronze. (Photo by A. Einarsson).*

Connecting two alloys in electrolyte, such as water, can lead to anode-cathode reaction where the less noble metal will dissolve to give electrons to protect the more noble alloy. This can clearly be seen in figure 2.6.2 where one-way valve from cold water well for cooling water made from cast iron house has a bronze connector and sieve. The cast Iron as less noble than the bronze is suffering from rapid corrosion.

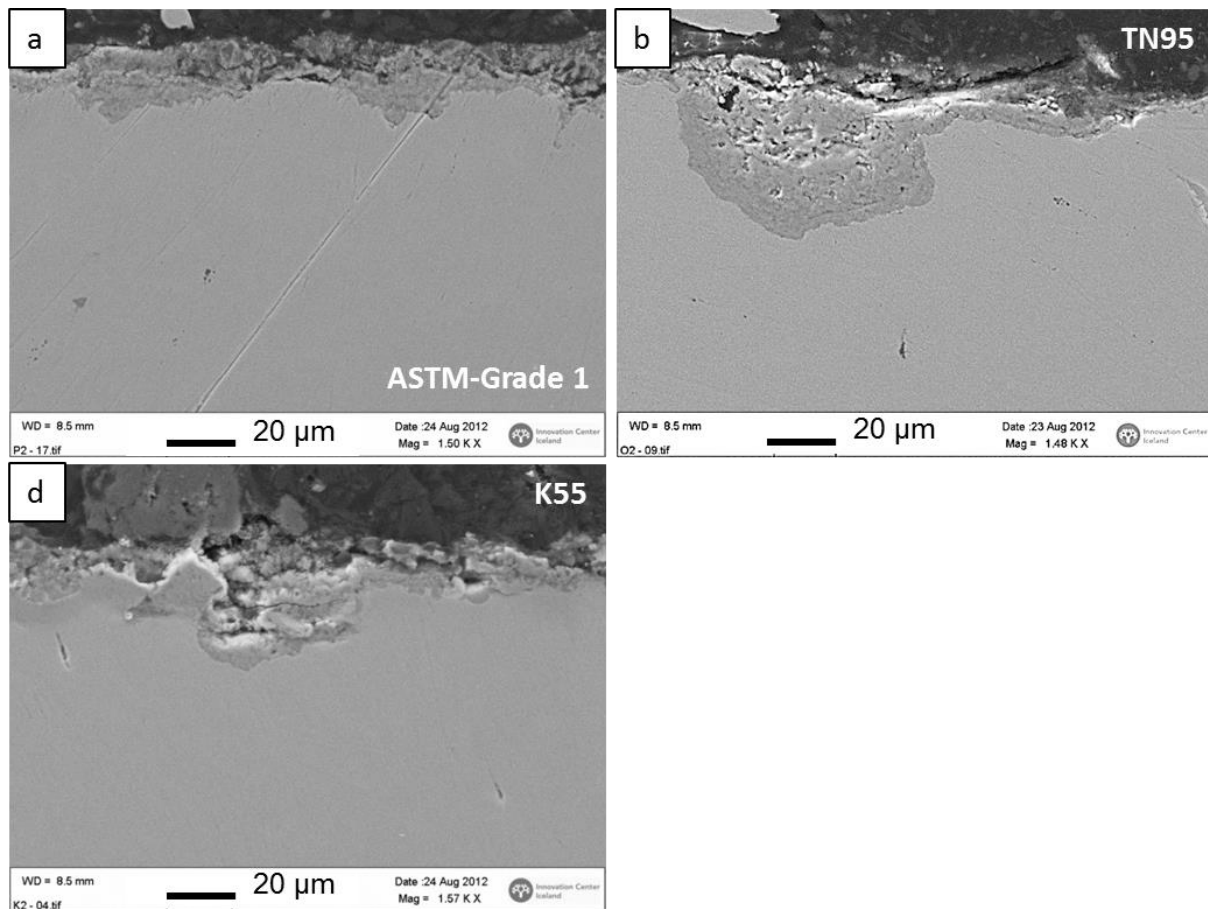
**Figure 3.1.1.** SEM images of the cross-sections of the carbon steels after testing (a) ASTM Grade A-1, (b) API TN95, and (c) API K55 (Karlsdottir et al., 2015).

Carbon steels or low alloy steels with less than 0.25% C and 0.4-1.5% Mn are the dominating materials used for geothermal wells, for pipes and equipment above ground. In general, this material has shown to be both economic and long lasting for the geothermal wells mainly used in Icelandic high temperature wells is API K55 grade. API TN95 has been used were higher strength and creep resistance is required like in the uppermost section of the IDDP-1 well. In general carbon steel has shown long lasting properties in geothermal use, but with the exception were the pH level has dropped and when condition has allowed condensation on the material surface, see chapter 2. This is also the experience from the corrosion testing experiment where the carbon steel specimens in direct contact to the superheated IDDP-1 steam at 360°C measured with corrosion rates below 0.1 mm/year. The low amount of additives in the TN95 does not help in corrosion resistance and the pitting corrosion was actually quite extensive for the TN95 in the IDDP-1 steam testing (Karlsdottir et al., 2014). Above ground in diverse equipment the carbon steels have suffered from erosion-corrosion problems as can be seen from the erosion-corrosion test with the IDDP-1 steam (Karlsdottir et al, 2014). However, carbon steels are good candidates for use in controlled conditions where condensate can be avoided and where erosion-corrosion is not a problem.

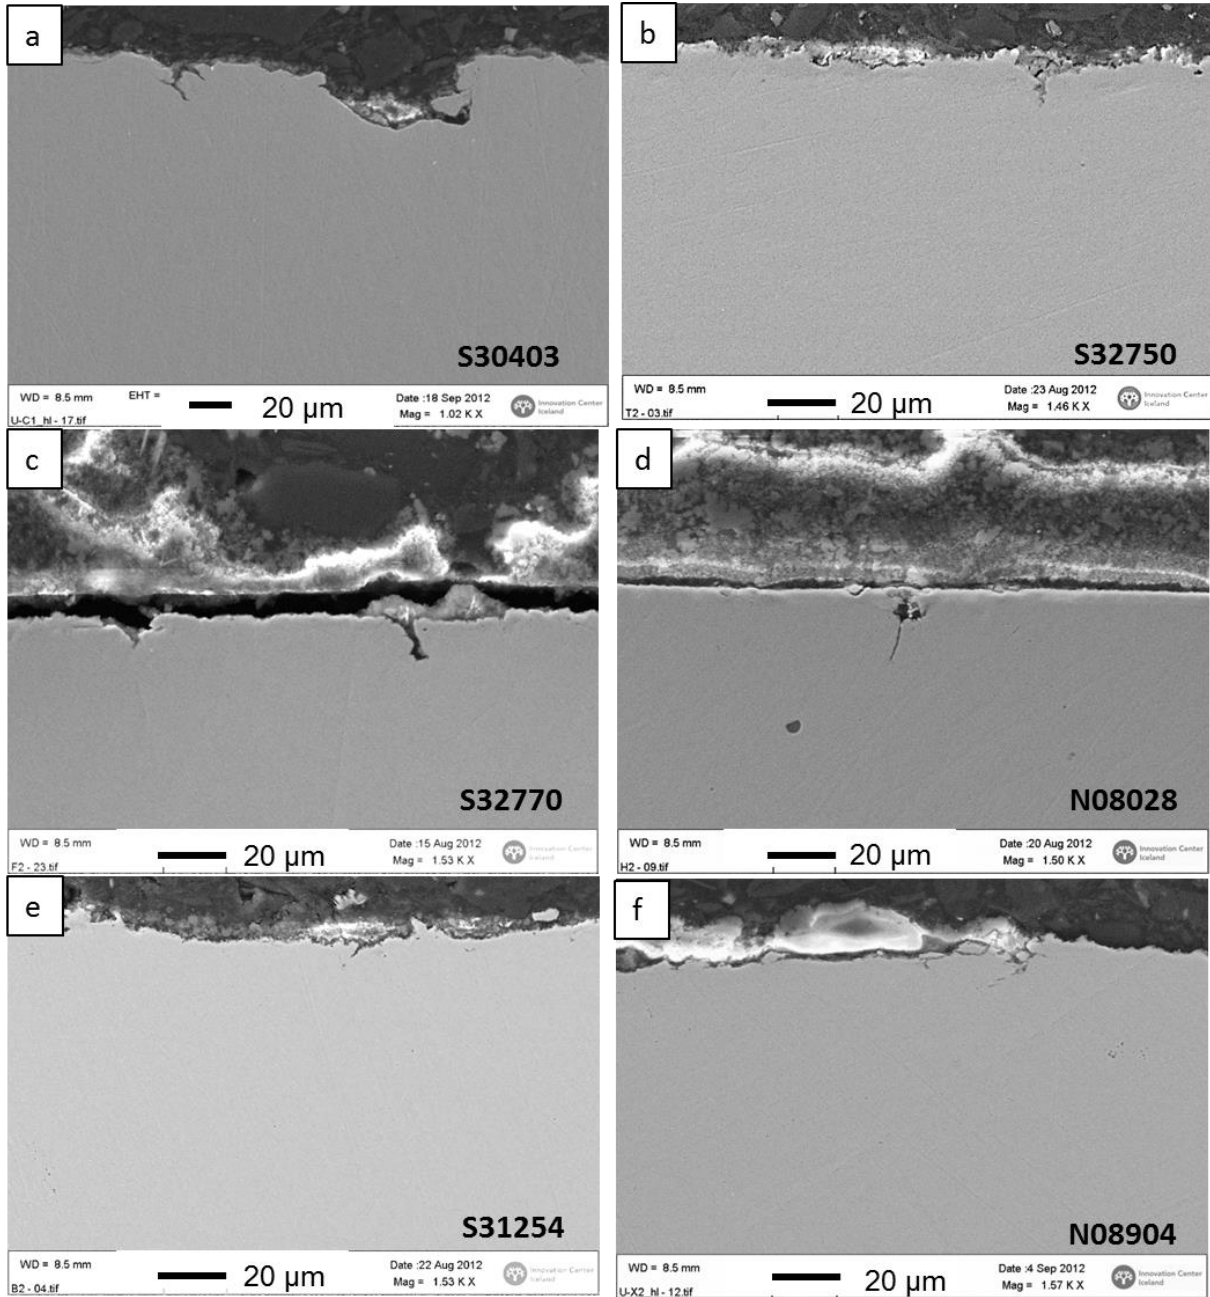
**Figure 3.2.1.** SEM images of the cross-sections of the stainless steels after testing (a) S30403, (b) S32750, (c) S32770, (d) N08028, (e) S31254 and (f) N08904. (Karlsdottir et al., 2015).

Stainless steels are steels containing more than 12% Cr and are often alloyed further with Ni, Mo and N. Stainless steels have a wide use in applications in the geothermal power production, mainly in diverse equipment's and piping. They have not been used in geothermal wells in Iceland. In general, this material group can be divided into two major groups when used in geothermal fields, Austenitic stainless steels and Duplex stainless steels. Both groups have long history of use in geothermal fields in Iceland and have been proven as a proper material for wide variety of applications. For higher temperatures above 250°C it is not recommended to use the Duplex type due to its structural change, shown as change in the material tensile strength above that temperature. Testing in IDDP-1 steam has shown erosion-corrosion damage for S32707 (Karlsdottir et al., 2014). Below 250°C the Duplex types S32507 and S32707 have both excellent resistances to corrosion and during testing in IDDP-1 practically no problems in use were detected. The Austenitic types can in fact be divided into two types, the lower alloyed types AISI 304 and AISI 316 and then the higher alloyed S31254, N08904 and N08028. The 304/316 types have shown to have limited resistance to corrosion and suffer from diverse corrosion forms in high temperature steam such as in IDDP-1. These results indicate limited use for these lower alloyed austenitic stainless steels in such conditions. The higher alloyed austenitic steels have shown better performance, especially the S31254 type. In one instance, the heat exchanger test, evidence of intergranular stress corrosion cracking was found in this material which was the only case where problems were found with the

S31254 material (Karlsdottir et al, 2014). In general, the stainless steels, especially the higher austenitic grades, can be considered as good candidate materials for use in high temperature geothermal steam with temperatures above 250°C.

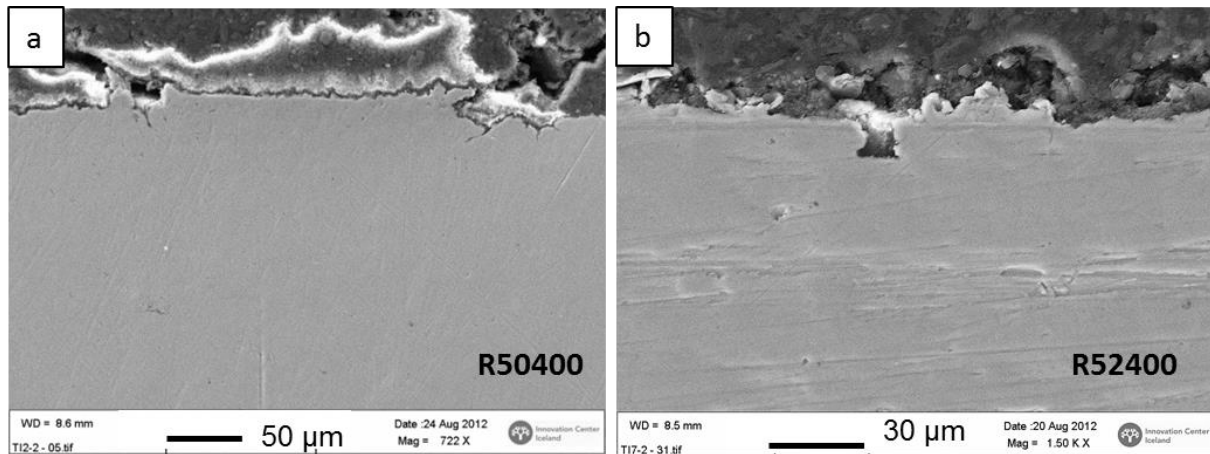
**Figure 3.4.1.** SEM images of the cross-sections of the titanium alloys after testing (a) R50400, and (b) R52400. (Karlsdottir et al., 2105).

Two types of titanium alloys were tested in the IDDP-1 steam, type R50400 and R52400. The R50400 type suffered from narrow pitting but the R52400 type alloyed with Pd showed more resistance. There is some concern with regard to HF containing steam like in IDDP-1 for the R50400 type were the R50400 has more resistance to HF containing steam due to the Pd alloying. In general, the concern of strength for Titanium alloys can limit their use at higher temperatures (>400°C). The possibility of hydrogen embrittlement is also of concern for low pH environment at higher temperatures (>80°C).
